# Plat of Survey

Being a part of the West Half (1/2)  
of the Southwest quarter (1/4) of Section 23  
Township 4 North, Range 5 East, Richland  
Township, Defiance County, Ohio.

For... Marlene E. Johnson

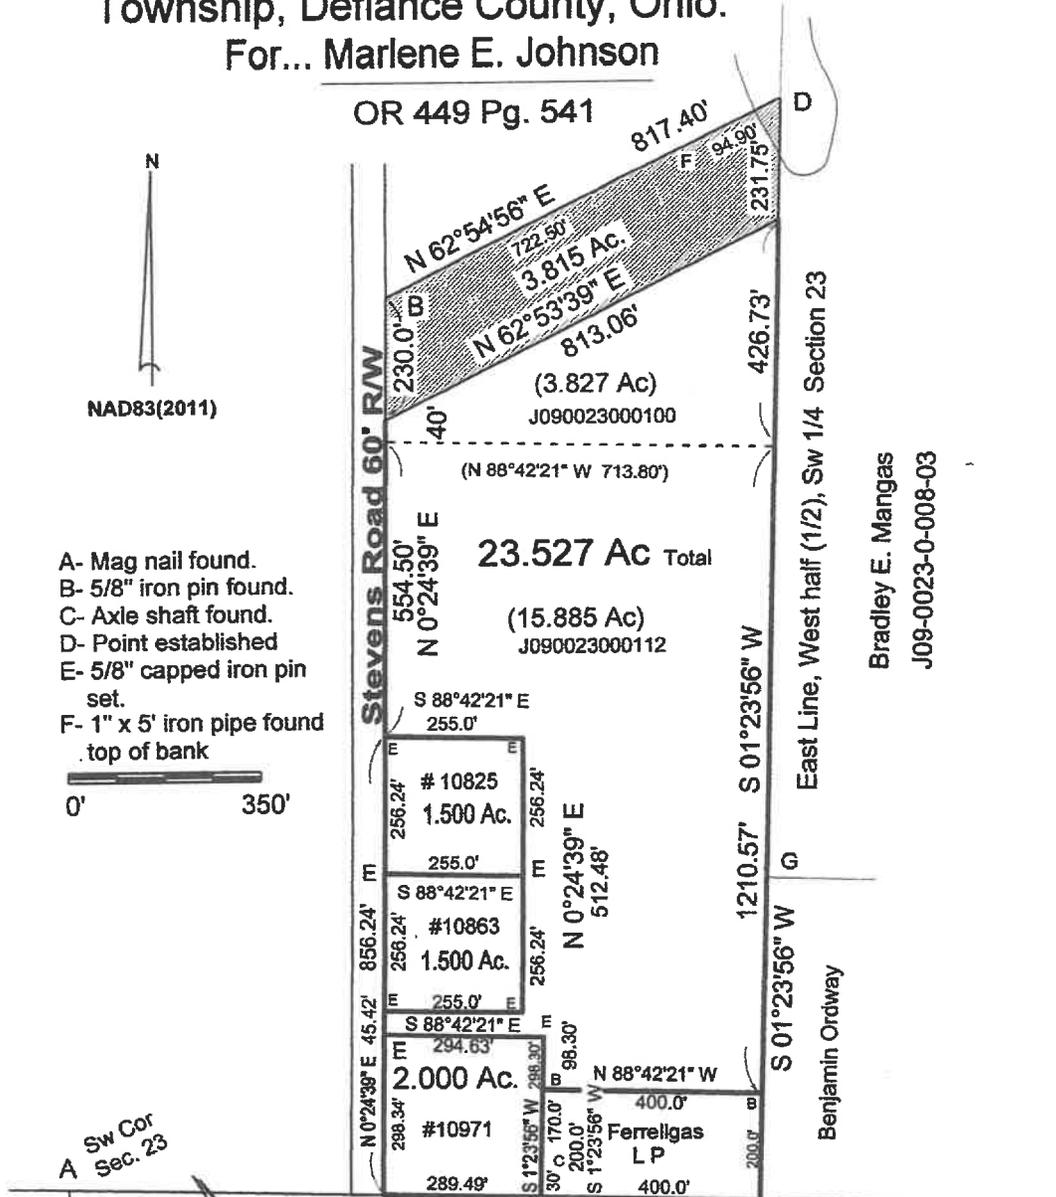
- A- Mag nail found.
- B- 5/8" iron pin found.
- C- Axle shaft found.
- D- Point established
- E- 5/8" capped iron pin set.
- F- 1" x 5' iron pipe found top of bank

Harris Rd.

635.50'  
S 88°42'21" E

## State Route 281
